Case 330 : Narrative

Case Vehicle (A): 2002 Saturn	Vehicle (B): 2002 Saturn
Type: SL1, 4-door sedan	Type: SL1, 4-door sedan
Driver: 40-year-old female	Driver: 19-year-old female
CDC: 12-FYEW-3, 09-LBEW-1	CDC: 99-0000-0, 99-0000-0

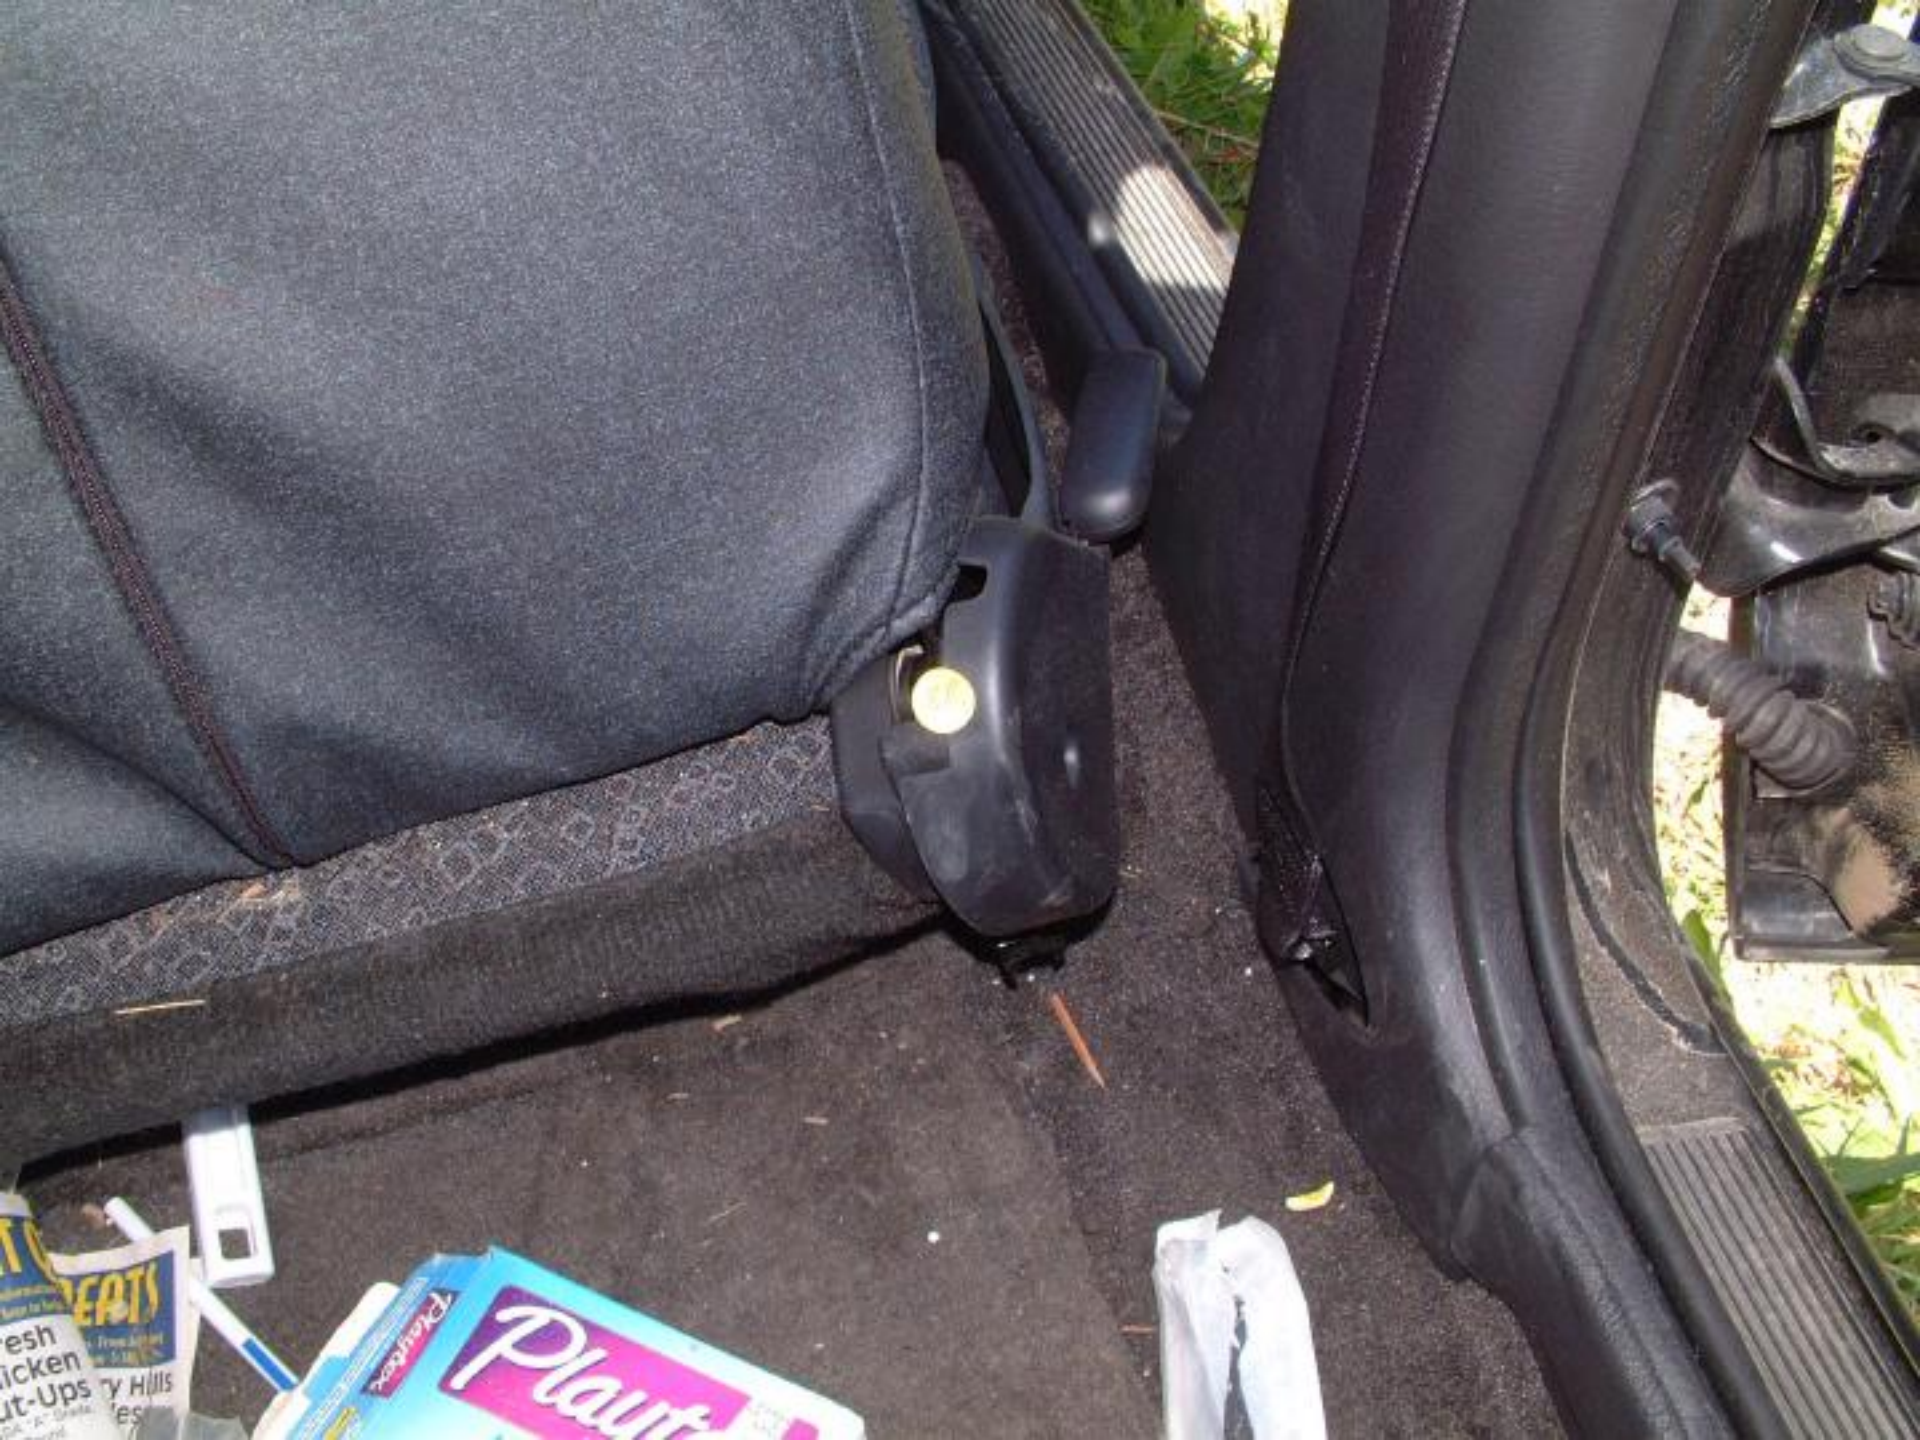
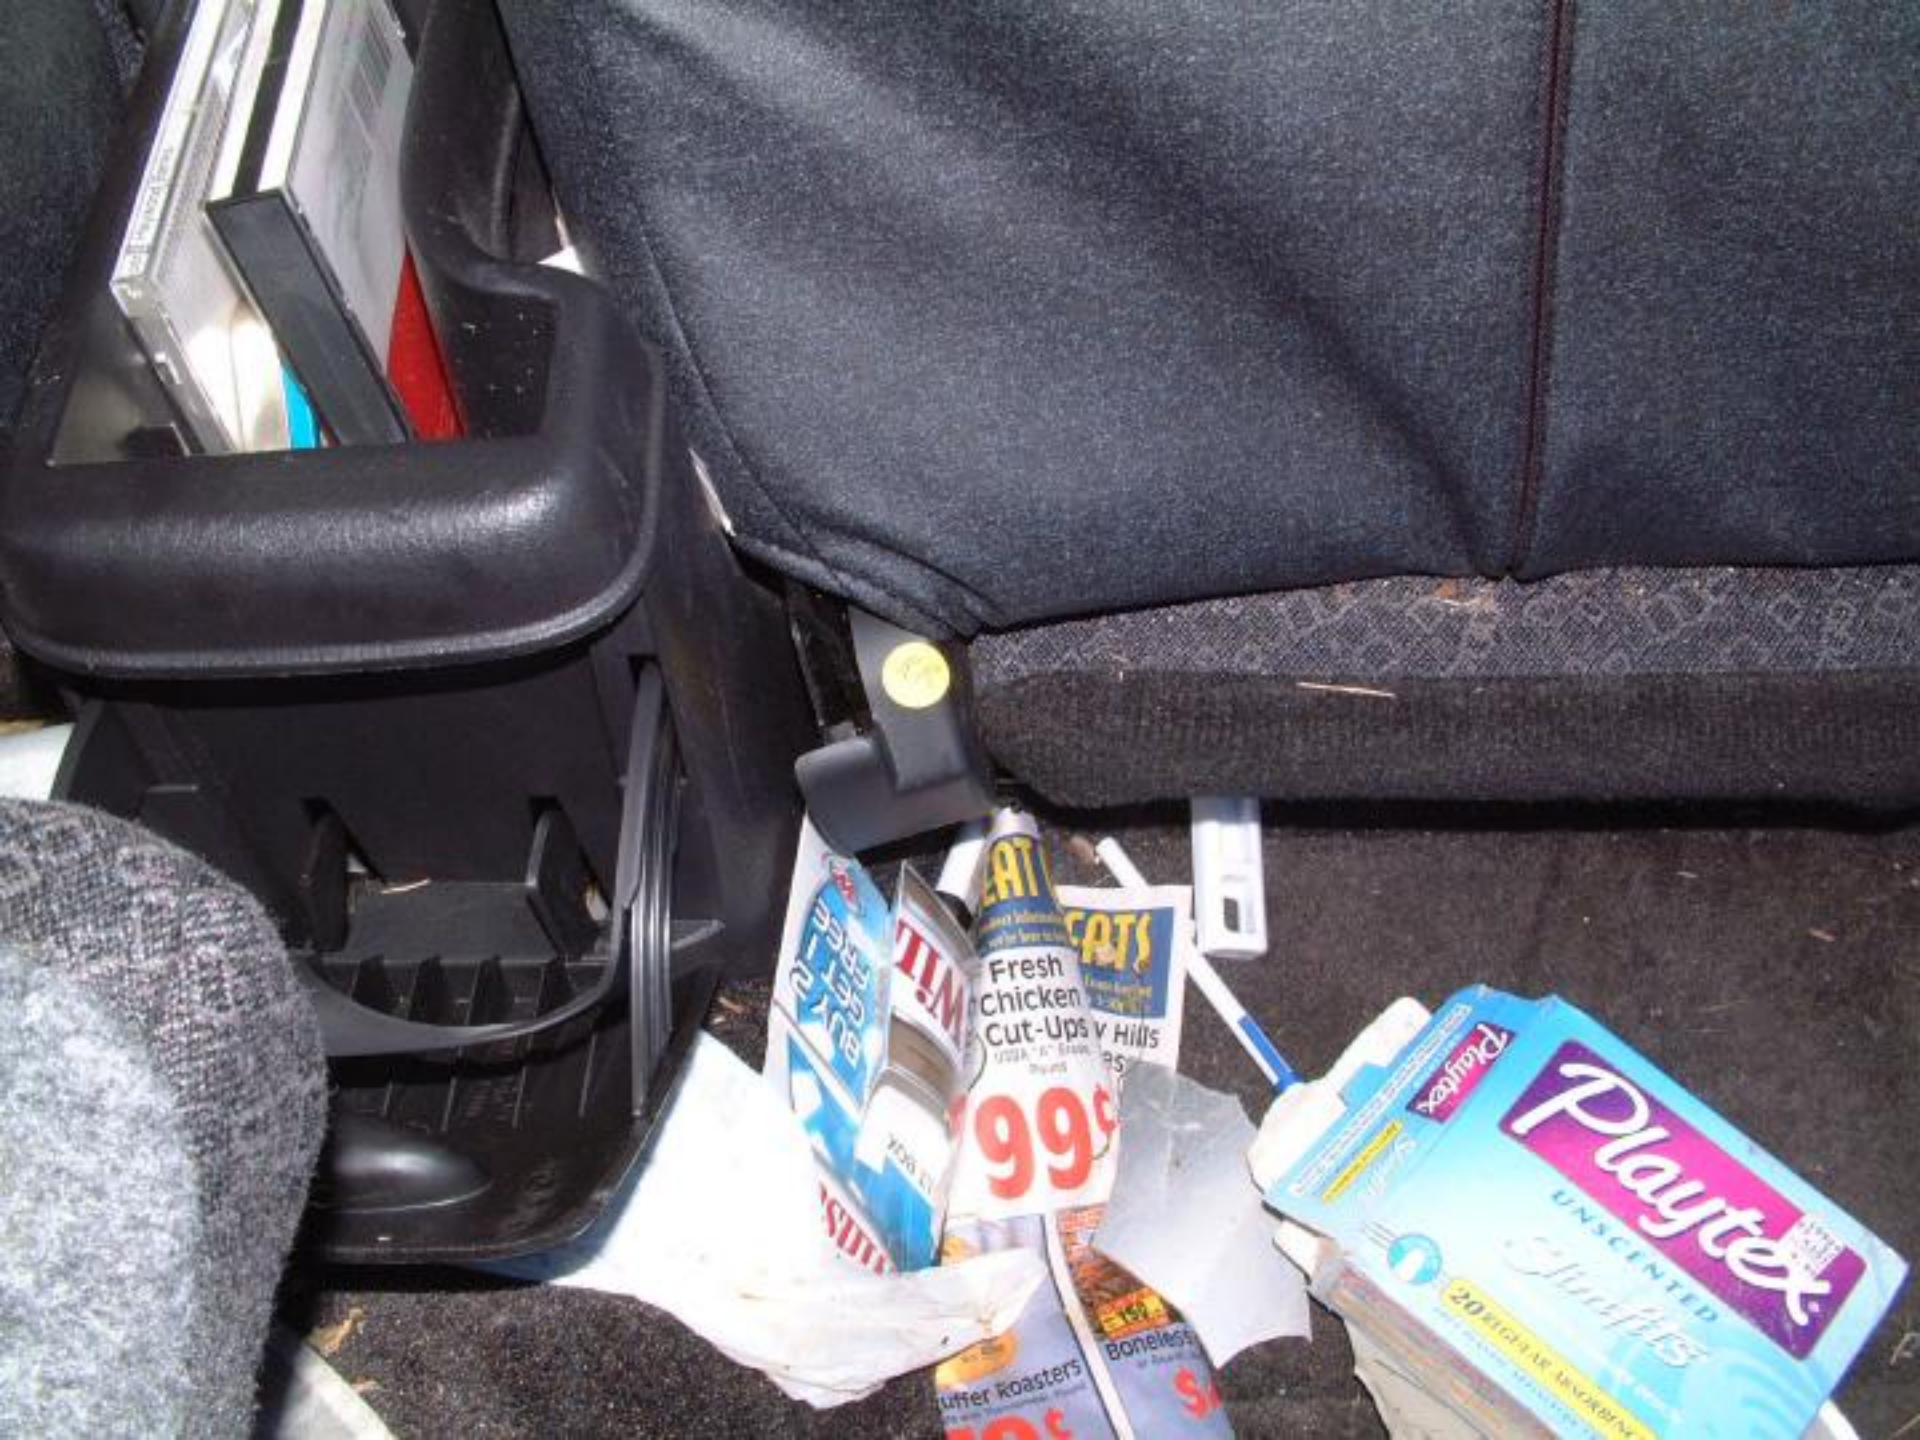
[86](#) The 5-ft, 4-in, 160-lb, 57-year-old female right-rear passenger was **not** using the three-point belt. [87](#) There were no webbing imprints on the recessed plastic D-ring and she stated that she was not using the seatbelt at the time of the crash. On impact, she moved forward and to the left relative to the vehicle interior, into and over the right-front seatback, and into the rearview mirror and windshield, as evidenced by [88](#) horizontal scuffmarks on the right seatback recliner mechanism, [89 90](#) forward deflection of the seatback, [91](#) the rearview mirror being broken off, and [92](#) cracks in the windshield with skin and hair deposits on the glass. After those contacts, it appears that she landed on the center console and transmission lever, [93](#) as evidenced by the dried blood and hair. She sustained a scalp laceration and unspecified brain injuries, resulting in unconsciousness for an unspecified time period with amnesia to the crash and cognitive recognition disorder. These head and brain injuries are probably due to head contact with the rearview mirror and windshield.
